TEST CERTIFICATE

Sample Information:		
Sample: Aluminum Microchannel Heat Exchanger	Report No: 21014952/Z	Job Code: STRC/21014952
Sample Description: Aluminum Microchannel Heat Exchanger		Sample Received On: 17/09/2025
Ref No.: PO-00030, Date: 19/08/2025 & 00046, Date: 10/11/2025	Report Issue Date: 09/12/2025	Date of Testing: 17/09/2025 to 08/12/2025
Sample Condition: Ok	Sample Quantity: 1 Piece	
Client Information:		
Customer Name & Address: Otolife Climate Solutions Private Limited Industrial Plot-82, First Floor, Udyog Vihar, Phase-4, Gurugram-122015 Haryana		
Information provided by the customer:		
Batch No.:	Nil

1. Acetic acid Salt Spray Test

Test Method/Specification : ASTM B368

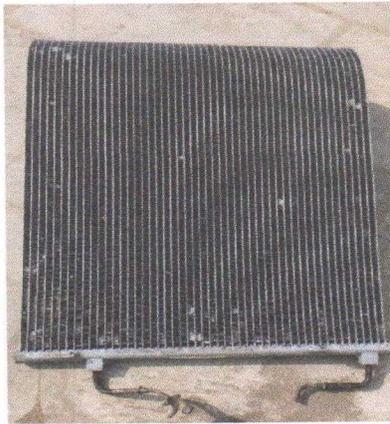
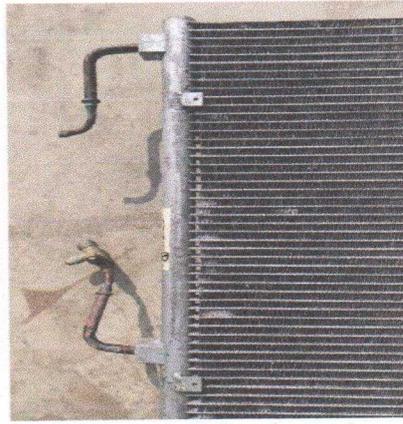
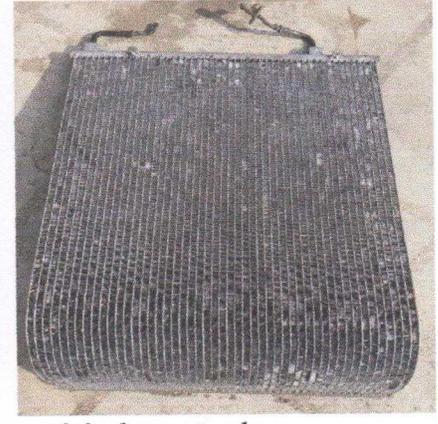
After Test

Check Specimens	Appearance check (visual check) Does a Corrosion or oxidation phenomenon occur on the surface of specimen?	Functional Check & Performance Check
Aluminum Microchannel Heat Exchanger	No	No leak found (checked at customer end)

Note: First schedule 720 hours completed the leak check at customer end. After that 280 hours more, test duration exposure of salt spray done. After 1000 Hours Leak Check done at customer end and no leak found in the sample.
